NCHRP Report 350 Test 4-12 of the Modified Thrie Beam Guardrail

PUBLICATION NO. FHWA-RD-99-065

DECEMBER 1999

6. Performing Organization Code	
7. Author(s) C. Eugene Buth and Wanda L. Menges		8. Performing Organization Report No. 404211-5	
9. Performing Organization Name and Address Texas Transportation Institute The Texas A&M University System College Station, Texas 77843-3135		10. Work Unit No. (TRAIS)

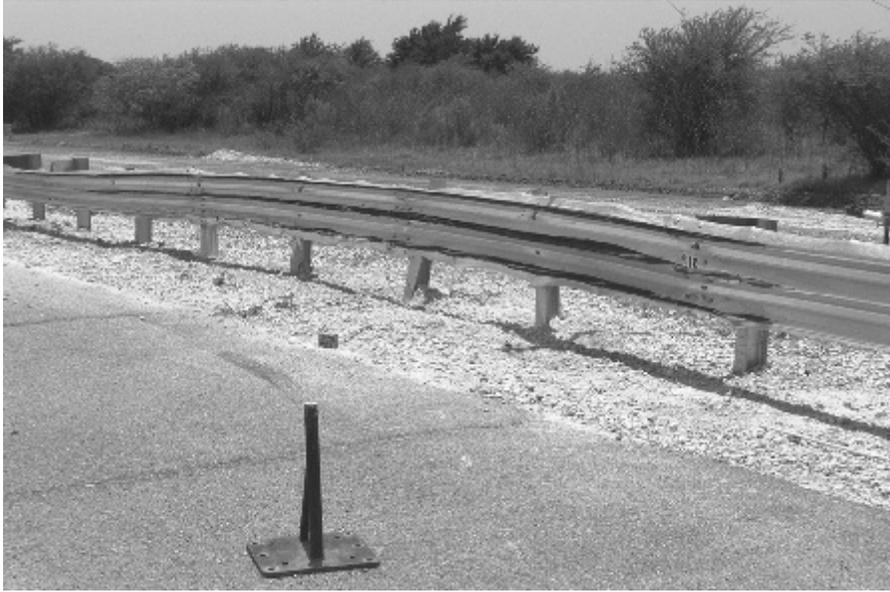
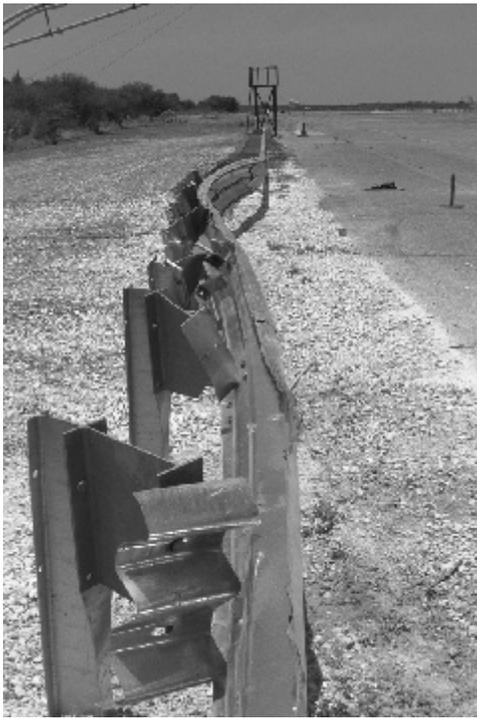
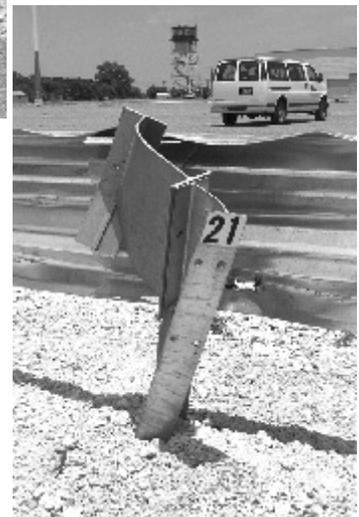
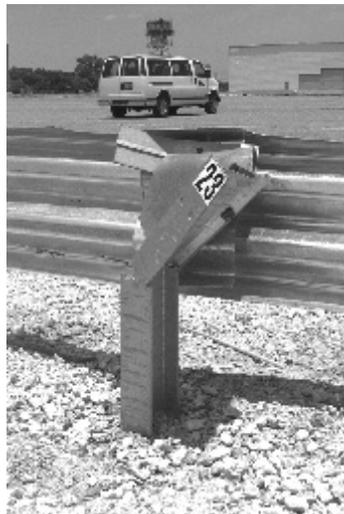
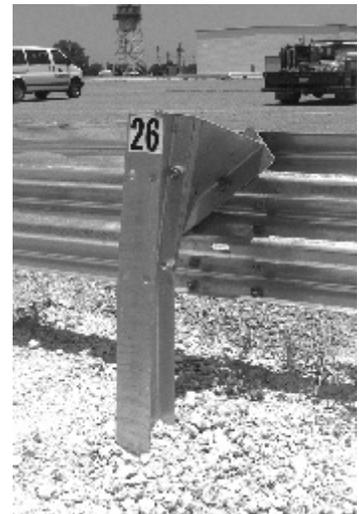
Figure 9. Installation near initial impact after test 404211-5a.

Damage to the modified three beam guardrail is shown in figures 8 and 9. Posts 19 through 26 were deformed and the blockouts on those posts were significantly deformed. The blockouts on posts 17, 18, and 27 were slightly deformed. The guardrail bolts pulled through the three beam at posts 20, 23, 24, and 25. Tire marks were on the face of posts 20 and 21. Length of contact during the initial collision was 16.0 m of which the truck rode on top of the three beam for 2.8 m. The second contact occurred between posts 27 and 28 and continued to just past post 30. The third contact occurred between posts 37 and 38 and the vehicle rode off the end, taking the ET-2000 head off the end. Maximum dynamic deflection during the test was 0.71 m and maximum permanent deformation was 0.51 m, both occurring near post 21.

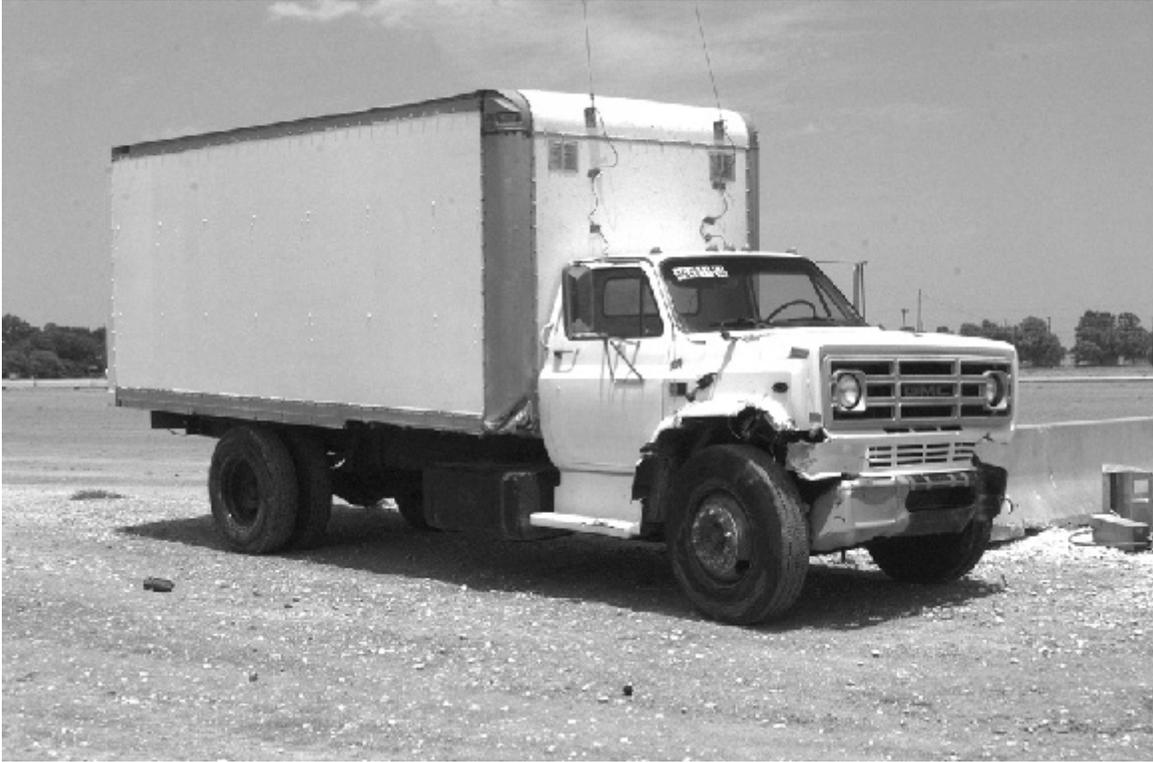
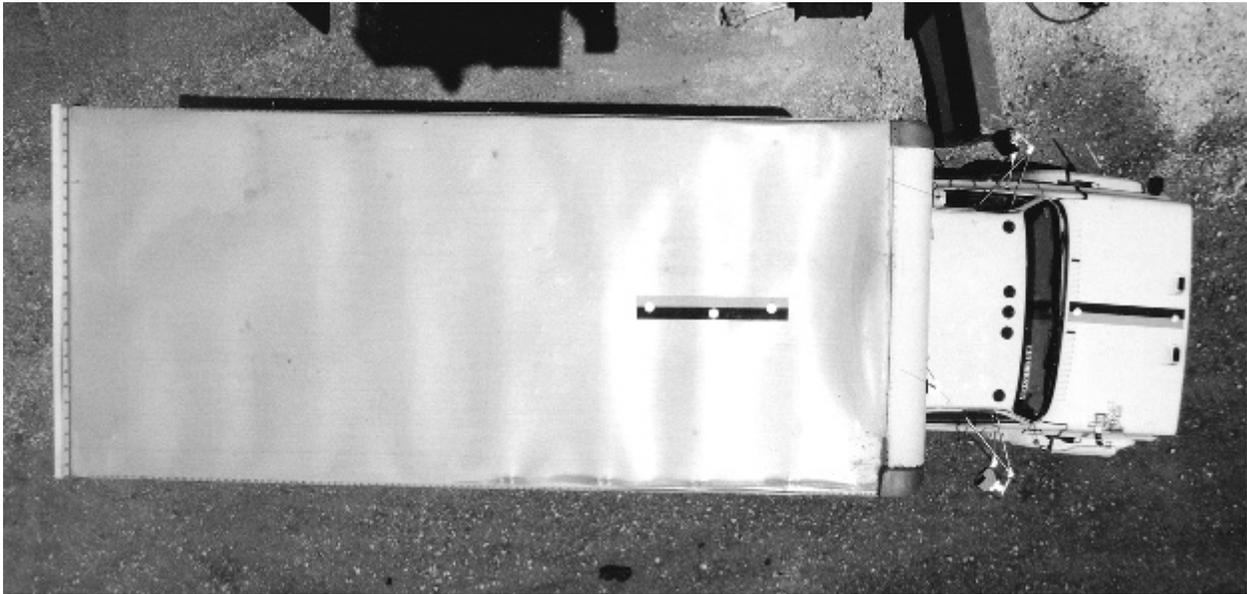
Figure 11. Vehicle after test 404211-5a.

Minimal damage was sustained by the vehicle as shown in figure 10. Structural damage was received by the front axle and right front wheel. The lower right front corner of the cargo box received a dent as well as the right side fuel tank. The bumper and supports, hood, right front quarter panel, grill, and right door step were damaged. The right door was jammed and the right outside tire received gouges. Maximum exterior vehicle crush was 140 mm at the right front corner of the bumper. The interior of the vehicle is shown in figure 11.
